UNITED STATES DEPARTMENT OF COMMERCE
National Oceanic and Atmospheric Administration
NATIONAL MARINE FISHERIES SERVICE

19 July 1993

Fox Avenue South CSO/SD

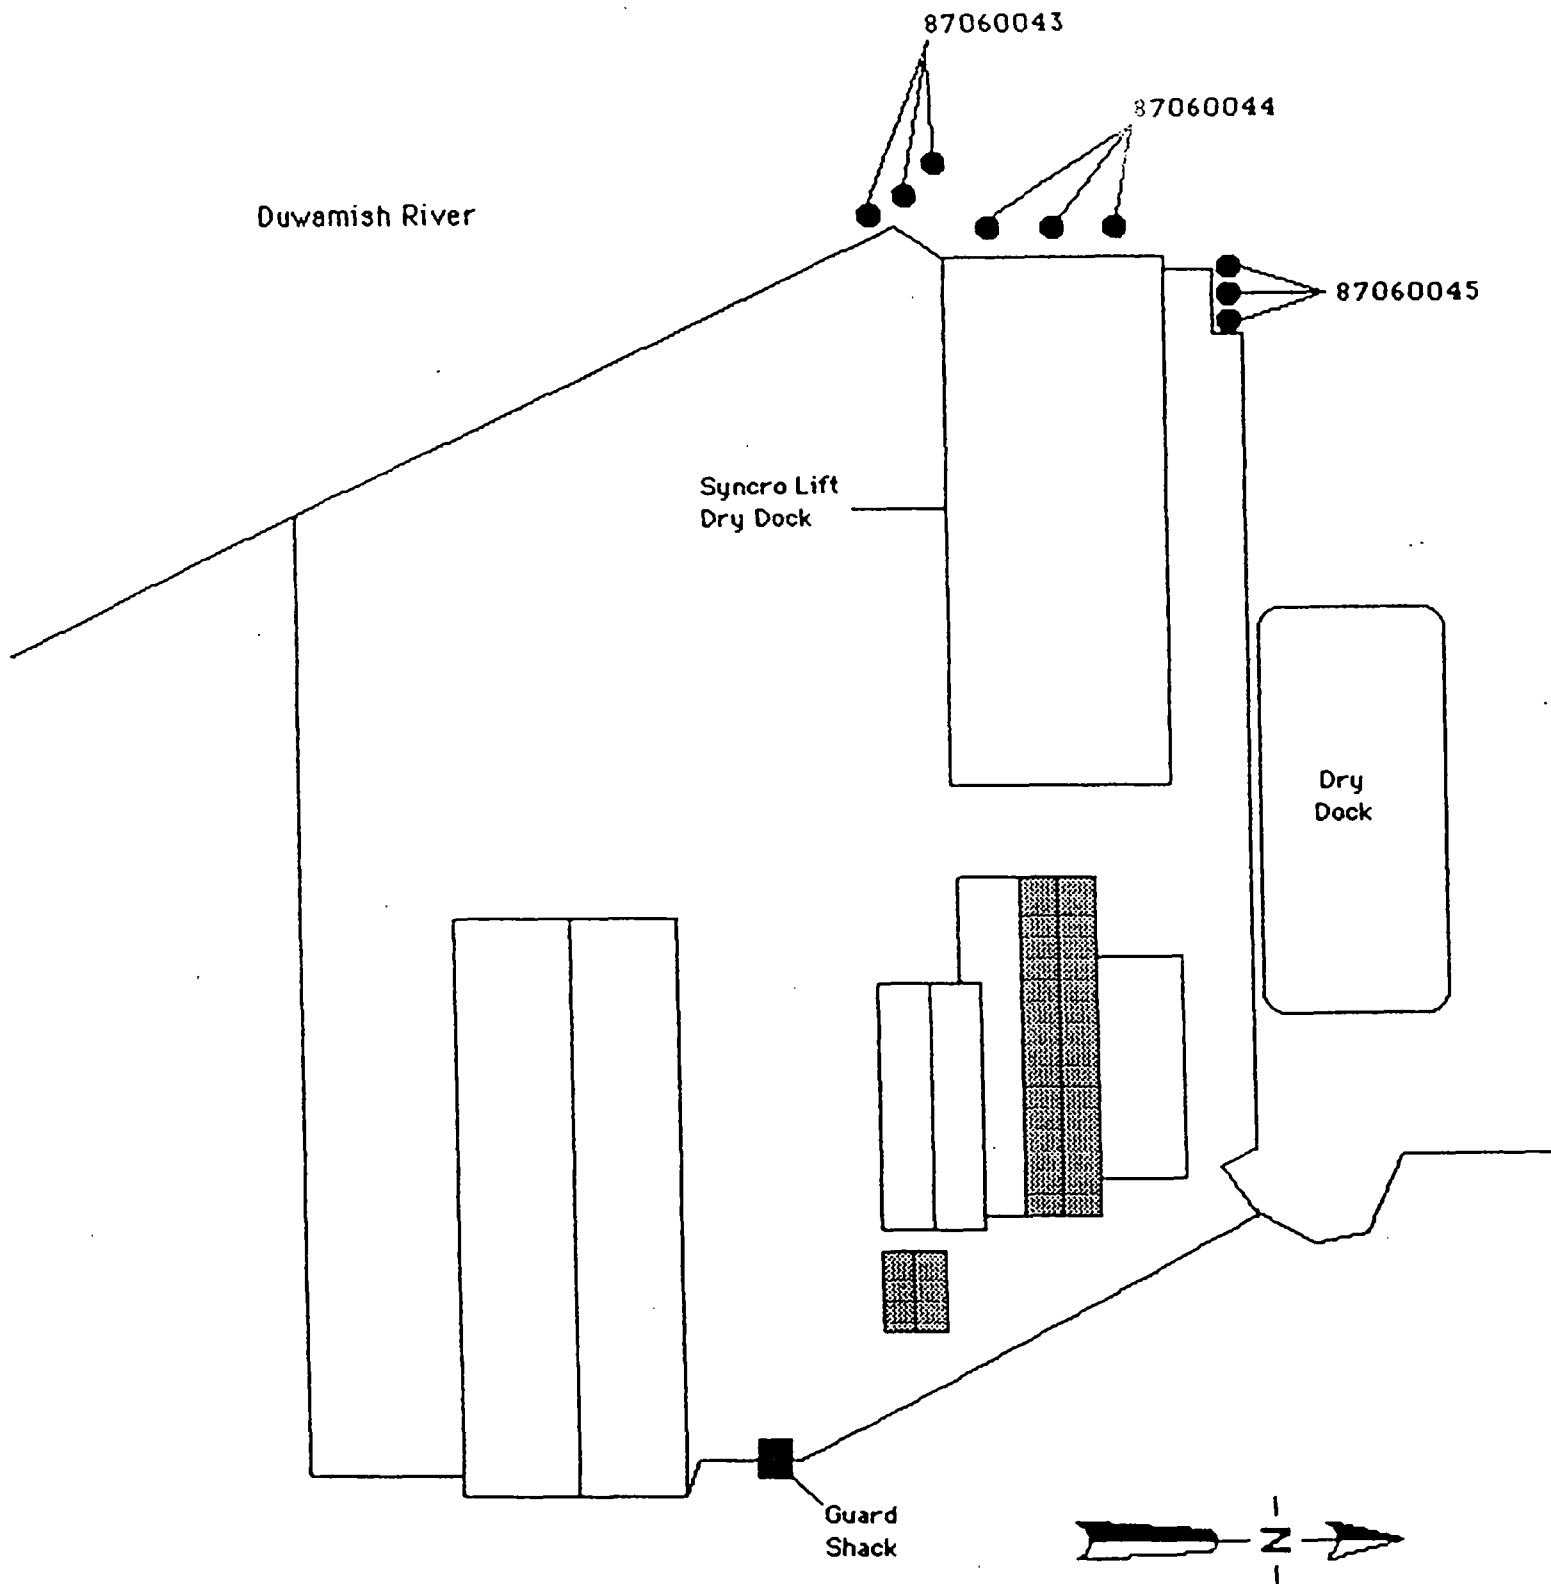
FIGURE 2

MARINE POWER & EQUIPMENT COMPANY

6701 Fox Ave. S., Seattle, Washington

● — Composite Sample Site
Scale Is Estimated
